THE EFFECT OF COMPRESSIVE STRESS ON THE  
EXPANSION OF BRICKWORK AND ITS  
IMPLICATION IN BUILDINGS

A dissertation presented in fulfilment of the  
requirements for the degree of  
Master of Science in Engineering to the  
Faculty of Engineering, University of the Witwatersrand,  
Johannesburg

November, 1977

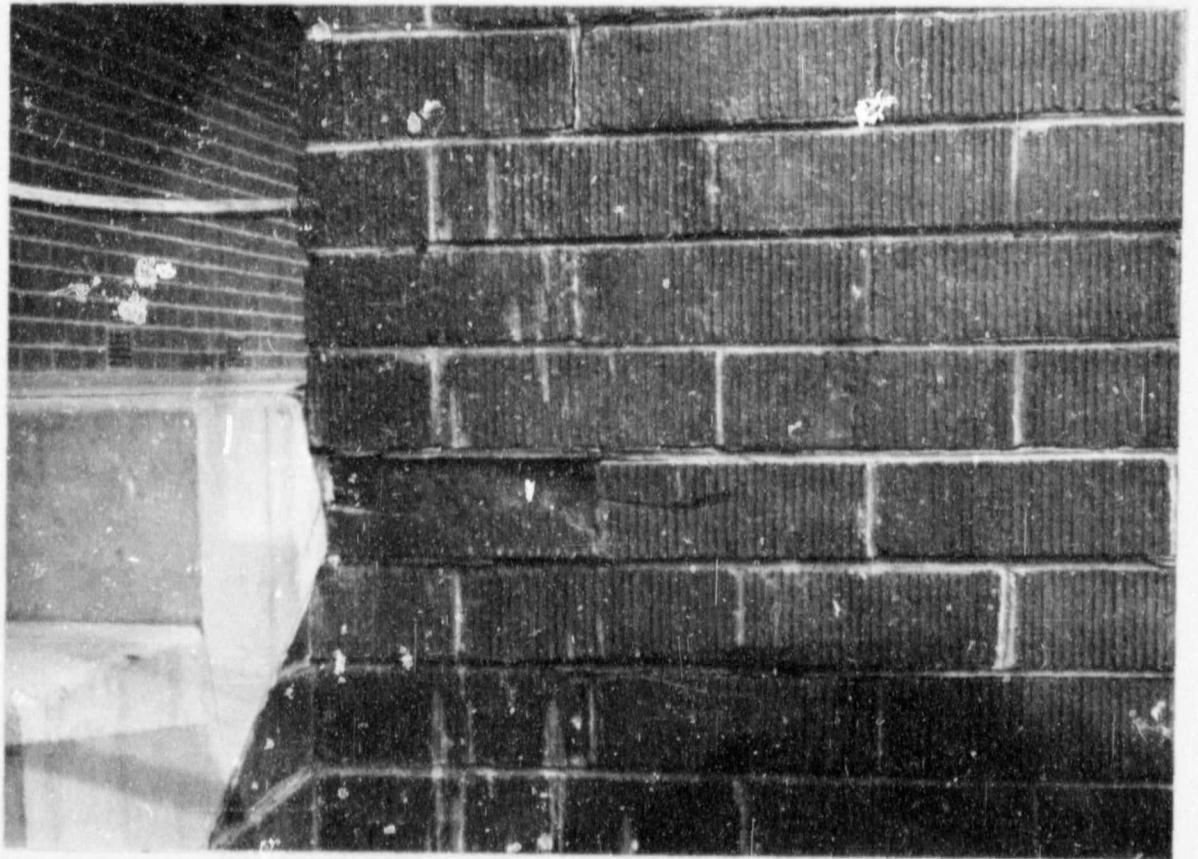
Figure 1 shows how a brick of fairly high strength at the end of a brick retaining wall of about 20 m in length has been crushed because of the forces developed due to the expansion of the bricks. Soil is retained by the brick wall to about the height of the crushed brick. The courses of brickwork above the crushed brick have moved horizontally disrupting the concrete to some extent. At the other end of the wall it was noted that the end portion, also against a flight of concrete steps, had been rebuilt.

FIGURE 1. Crushing of brick against concrete steps

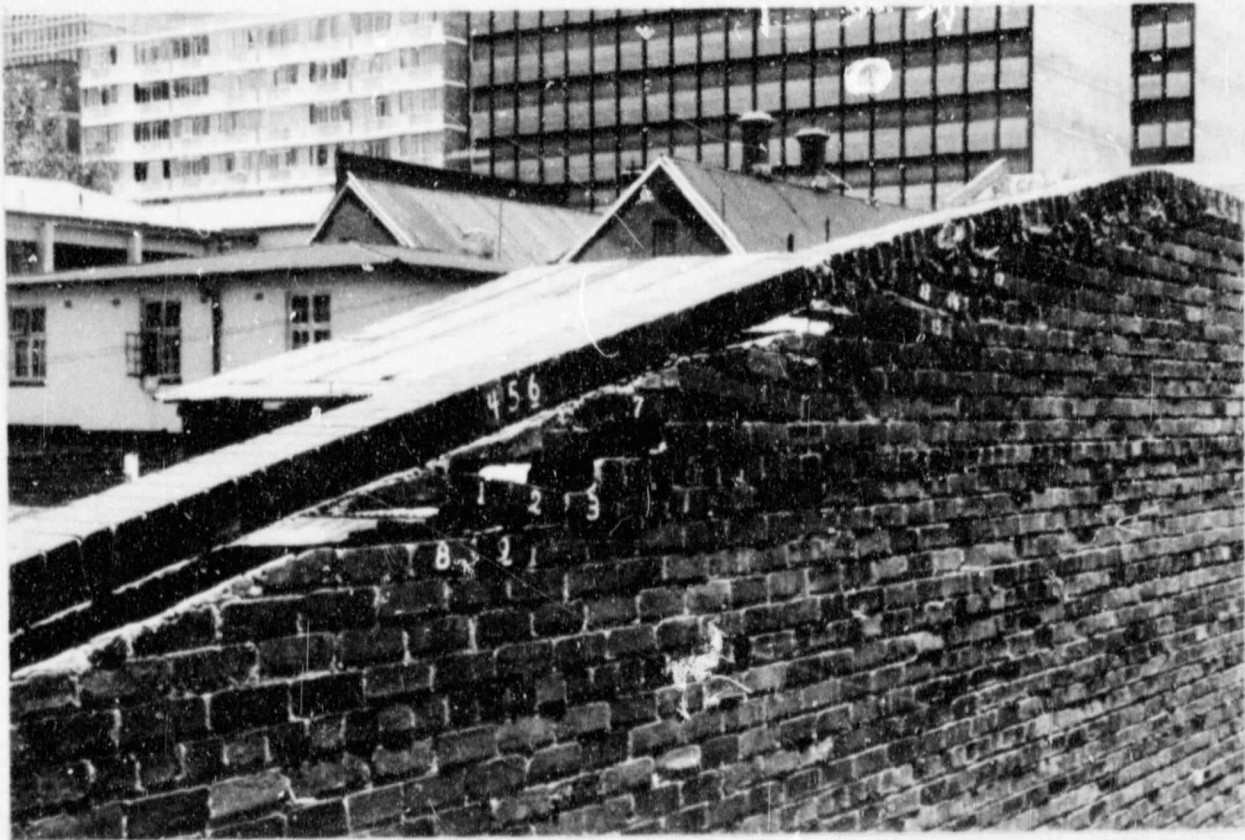
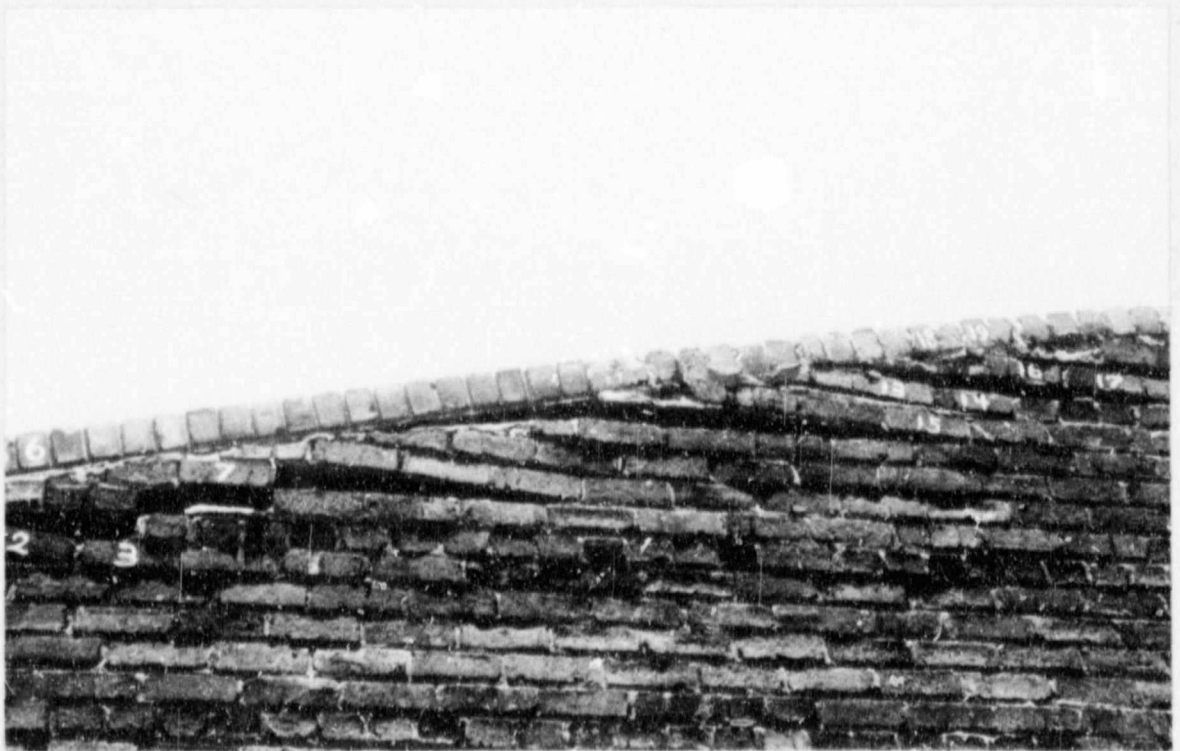
This wall was on the boundary of the property and formed a side wall of a building with a saw-toothed roof. There were three sloping sections of wall, two of which had been previously repaired at their ends and the middle section, 16,9 m in length, was about to be repaired. The disruption to the top of the middle section of the wall is shown on Figures 2 and 3. The wall had grown in height and the top

FIGURE 2. Disruption of top of sloping wall

FIGURE 3. Disruption of top of sloping wall

sloping header course had expanded more than the other bricks, while strongly restrained at its bottom end and partially restrained at its top end. The expansion movement of the header course was up the slope and combined with a greater horizontal expansion of the upper courses at the highest part of the wall caused the disruption shown. No bricks were observed to have crushed in this wall. A number of bricks about 1,3 m up from the bottom of the wall were selected and Demec measuring disks were fixed to each brick at 203 mm centres horizontally, as described in Appendix B. When the epoxy resin had hardened Demec readings were taken. The mortar round each brick was drilled out in turn and a second Demec reading was taken immediately on removal of each brick from the wall. The bricks were capped with the capping mixture described in Appendix C before being remeasured. Most of the bricks had increased slightly in dimension over a period of 7 days while awaiting capping.

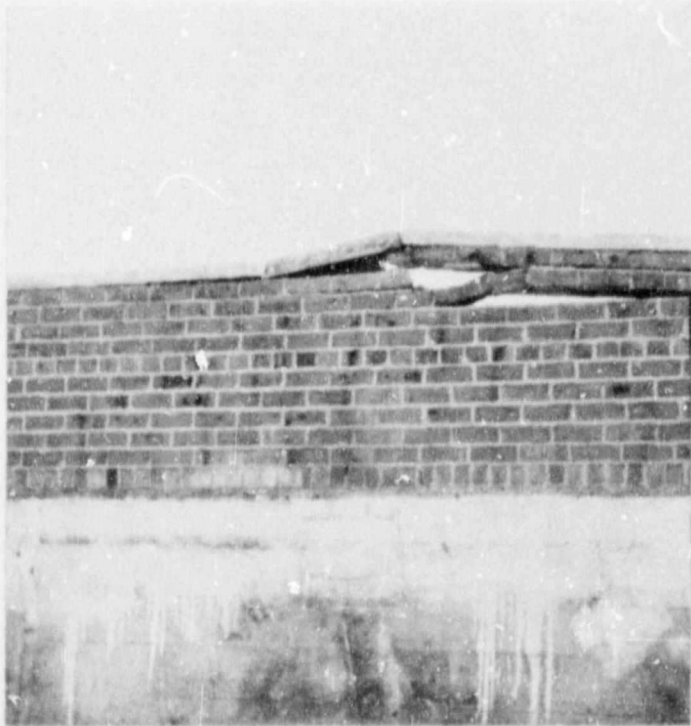
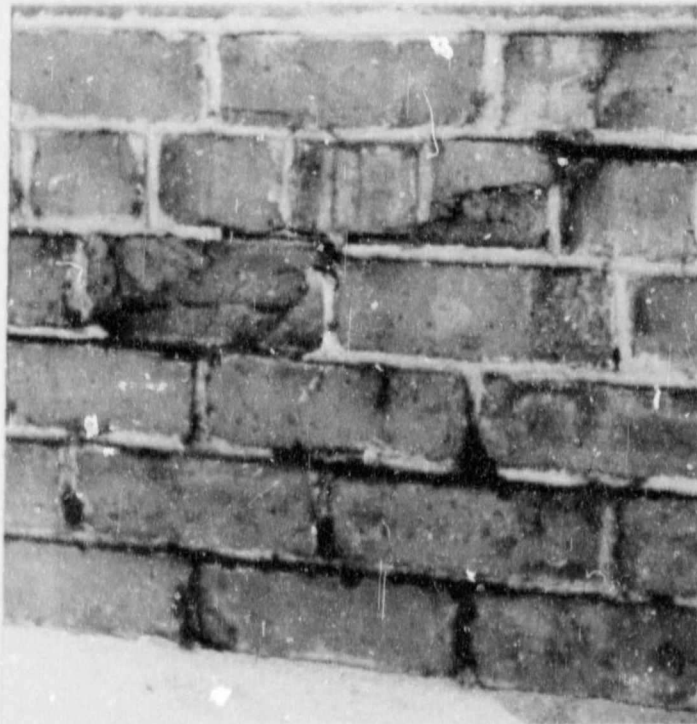
FIGURE 4. Upward buckling of top brick courses

FIGURE 5. Crushing of bricks in wall

The three top courses of brickwork in the middle of a 225 mm thick boundary wall of about 60 m length had buckled upward about 150 mm under the horizontal compression developed because of moisture expansion. Bricks in many of the courses below this inverted 'V' had been crushed. Figures 4 and 5 show this wall where it had failed. The bricks were judged to be of medium strength.

The failure took place at about the middle of the wall because the shear strengths of the horizontal mortar joints on each side of the failure were greater than the cross-sectional strength of the wall. The stresses had been induced by the elastic suppression of a gain in length due to the moisture expansion.

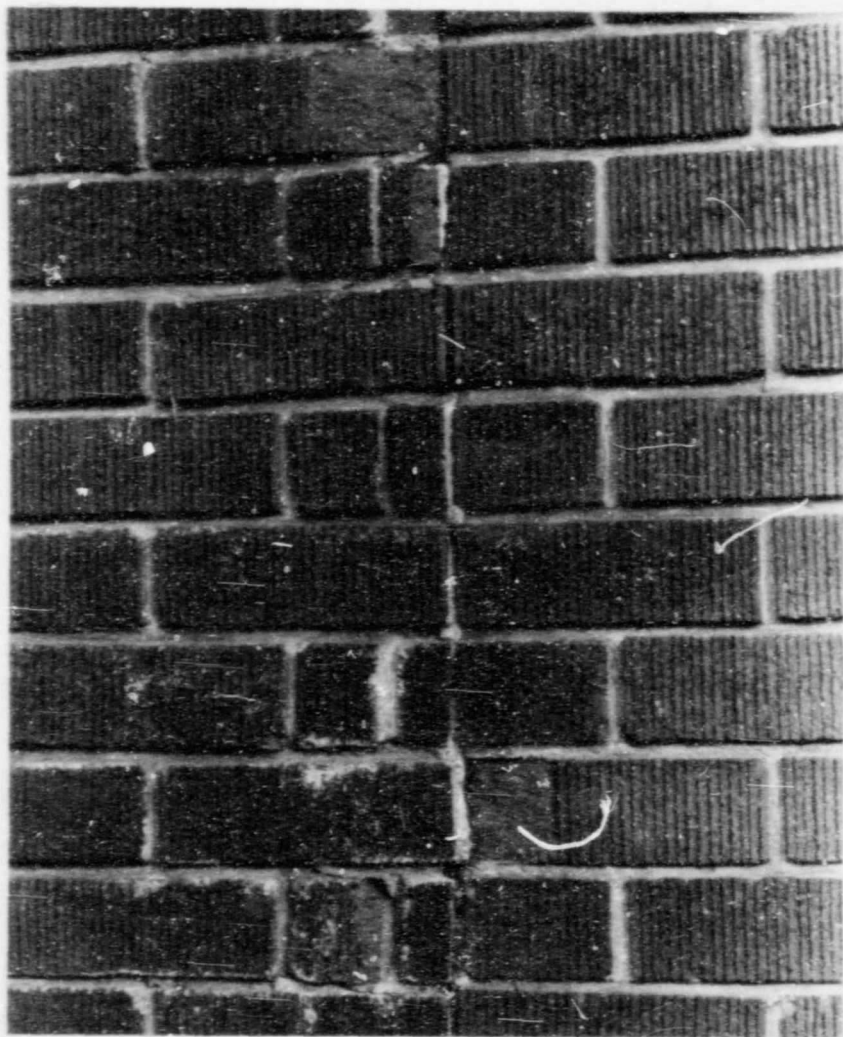
A wall about 2 m high and 9 m long was built on the same line between two heavily loaded walls about 6 m long which supported 5 storeys of a building above them. Although open vertical joints had been provided between the walls, when inspected the walls were very hard up against each other. As can be seen on Figure 6, the corners of bricks had flaked off at the vertical joints and some bricks adjacent to the joints had failed in compression. At the

FIGURE 6. Open joint that had closed

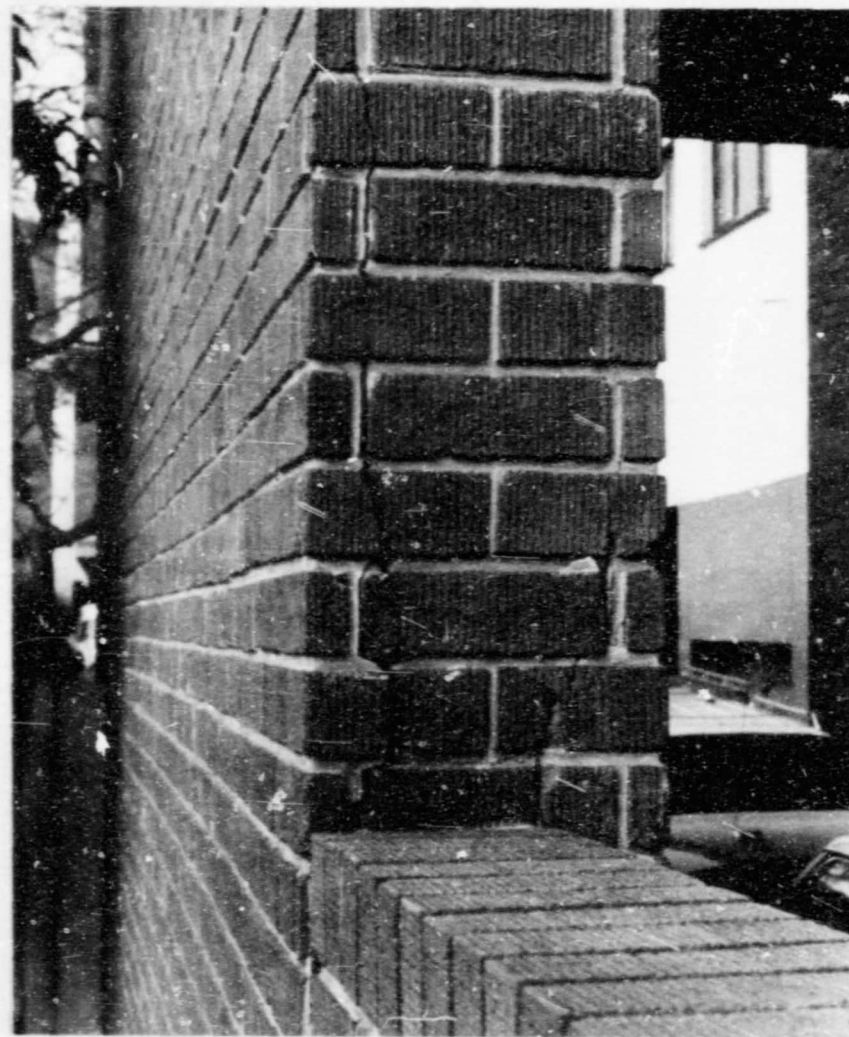
FIGURE 7. Compression damage to wall

2 m height the walls carrying the heavy vertical loads had been damaged by the top bricks of the lower wall forcing their way slightly into these walls, as shown on Figure 7.

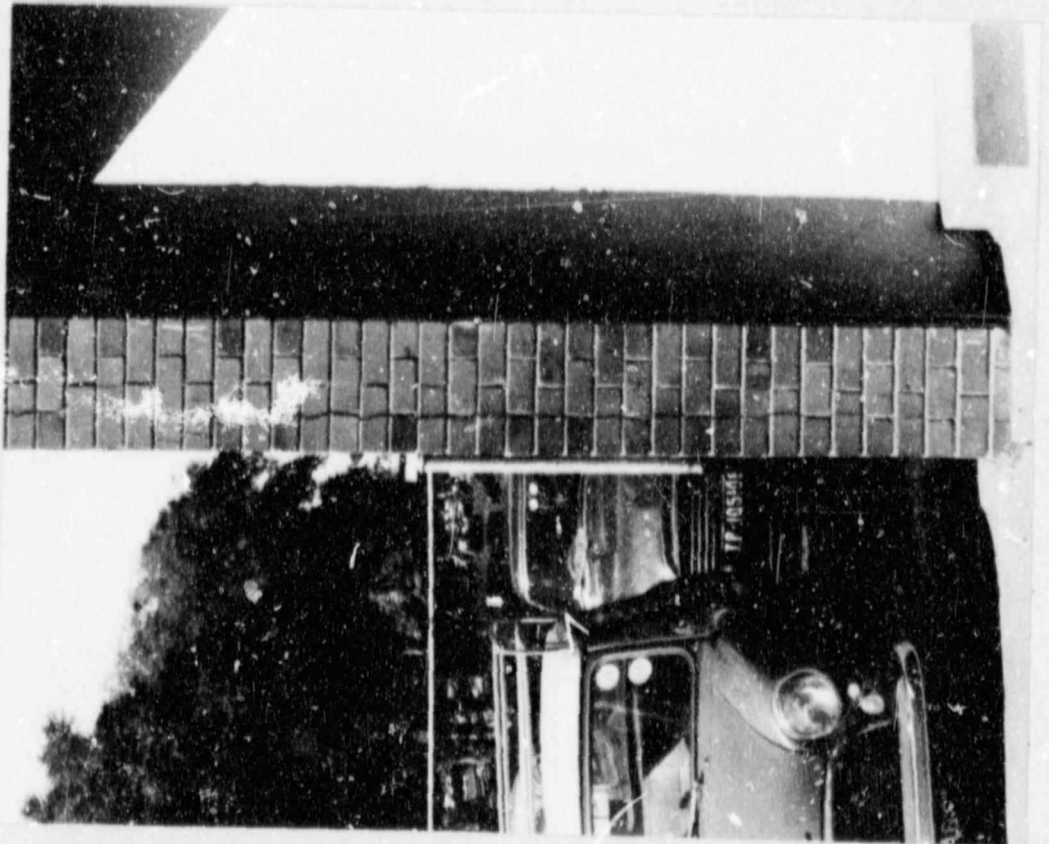
FIGURE 8. Vertical crack in column

Figure 8 shows a crack in a vertical column. Elsewhere in the building and in a boundary wall were evidence that these bricks were of an expansive nature. This column was at one side of a driveway into the building and carried six storeys above it. Inside the brickwork was a reinforced concrete column. Just how much the shrinkage and creep of the reinforced concrete column had contributed to the load on the brickwork and how much the expansion of the bricks had contributed cannot be said but the brickwork had obviously had to carry an excessive load which had split it vertically. Brick walls under compressive loads during testing crack vertically in this manner just prior to collapse failure. About 11 years ago this crack was about 0,1 mm wide and is now 3,2 mm wide. Similar vertical cracking of expanding brick clad columns have been observed in other buildings.
